## PHOTO QUIZ

## The inability to flush a central venous catheter

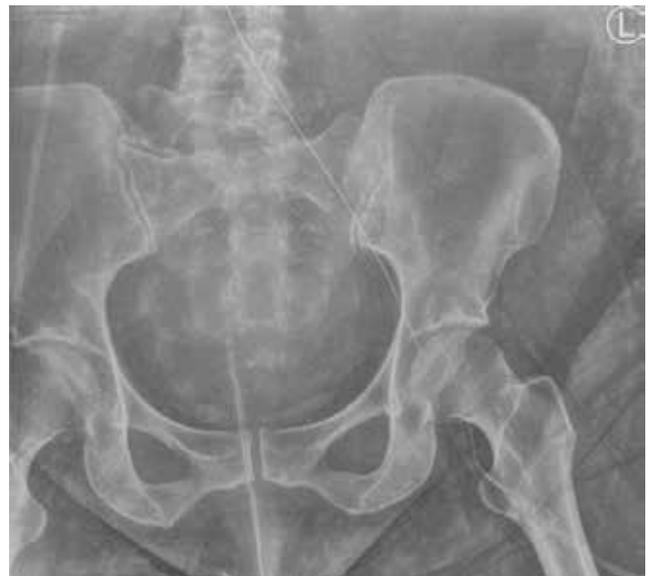
**Figure 1.** Abdominal X-ray, revealing a hyper-dense linear structure diagonally projecting over the head of the femur to the spinal column

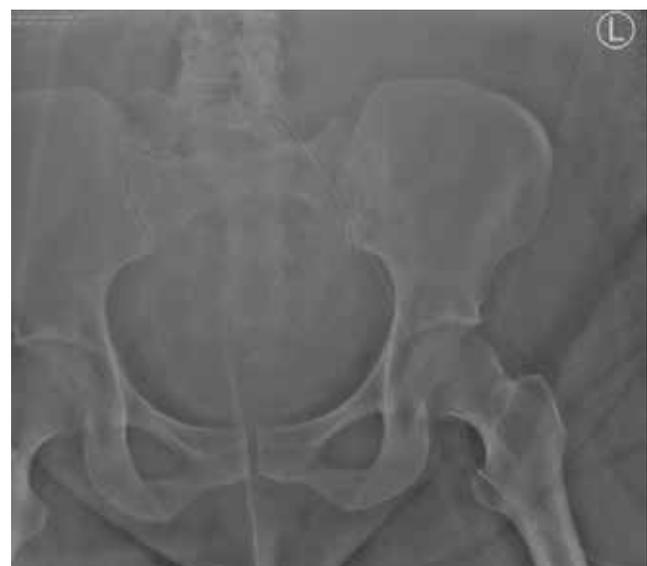
The abdominal X-ray shows a radio-opaque foreign body in the pelvis, which is a retained guidewire. The inadvertently lost guidewire is located on the right side of the spinal column, in the inferior vena cava. During a percutaneous procedure, the interventional radiologist accessed the left femoral vein and removed the 60 cm long guidewire with a snare device. The patient's family was informed directly and the incident was evaluated thoroughly.<sup>[1]</sup>

**Figure 2.** Abdominaal X-ray, the hyper-dense linear structure is a retained guidewire used for central venous catheter insertion.

centre is that every physician is directly supervised for at least three successful placements before being granted permission to insert a central venous catheter with supervision from a distance. With inexperienced physicians, we emphasise the importance of preventing distractions and limiting workload during the procedure. Also, we advise to routinely check the presence of the guidewire on the tray after each procedure.
